Manhole Inspection Summary

Manhole # S45M2_003MH

Location Address: **Benhill**

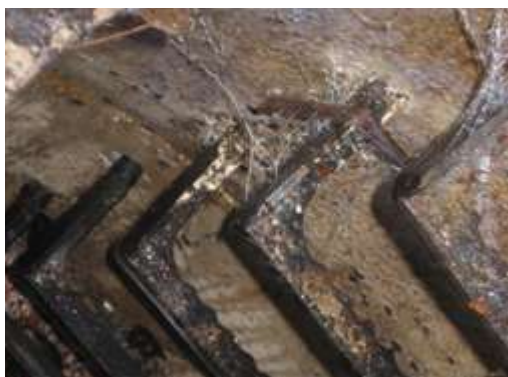
steps

Steps Count: **6** Missing: **0** ☐ Corroded

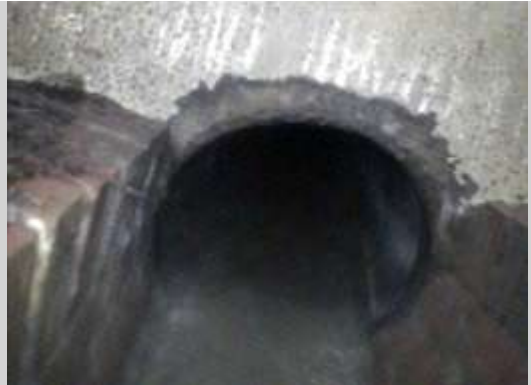
12 O'Clock Outflow

12 in. Circular Gravity Sewer
Pipe Out @ 12 O'Clock

Pipe Height: **13.2** (in.) Rod and Bar (Angled)
Pipe Material: **Clay** ☐ Pipe Lined
Invert Depth: **7.02** (ft.) Flow Characteristics: **Slow**
Deposits: ☒ None ☐ Mud ☐ Sludge ☐ Debris ☐ Grease
Silt Depth: (in.) Deposits Extent:
Infiltration: **None** Pipe Seal Cond: **Sound**

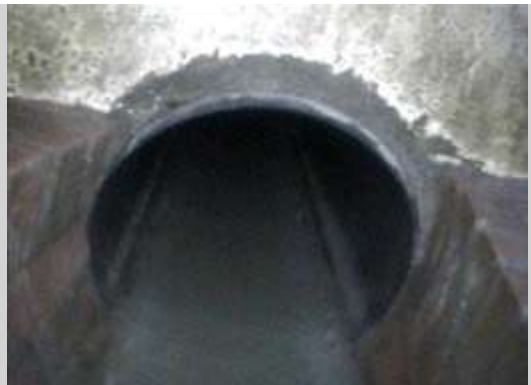
6 O'Clock Inflow

10 in. Circular Gravity Sewer
Pipe In @ 6 O'Clock

Pipe Height: **10.8** (in.) Rod and Bar (Angled)
Pipe Material: **Clay** ☐ Pipe Lined
Invert Depth: **6.79** (ft.) Flow Characteristics: **Slow**
Deposits: ☒ None ☐ Mud ☐ Sludge ☐ Debris ☐ Grease
Silt Depth: (in.) Deposits Extent:
Infiltration: **None** Pipe Seal Cond: **Sound**
